DFID Nepal Rural Access Programme 3 (RAP3)
Monitoring, Evaluation and Learning (MEL) Component

**TECHNICAL ASSESSMENT OF COMPLETED RAP
ROADS
(INDEPENDENT VERIFICATION - 2018 ROUND 2)**

Date: December 2018

Submitted by Itad

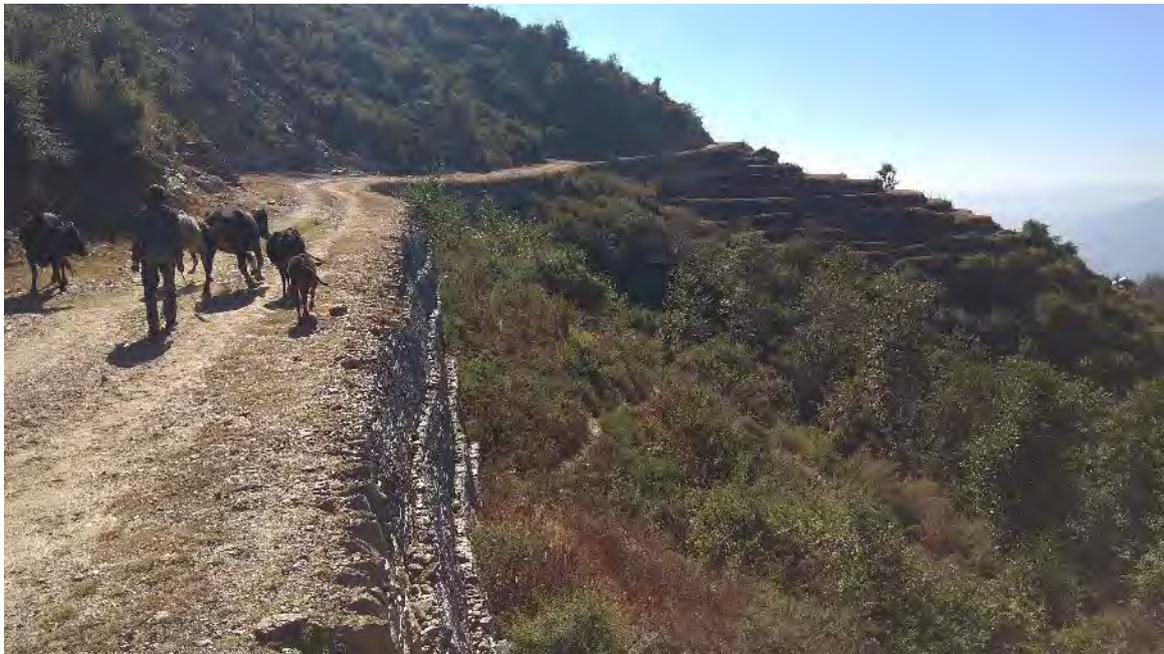
- The overall condition of the built road is good. It is in proper operable condition. Photo 1: Chainage 11+490 to 11+620. Good example of overall construction of length of road.

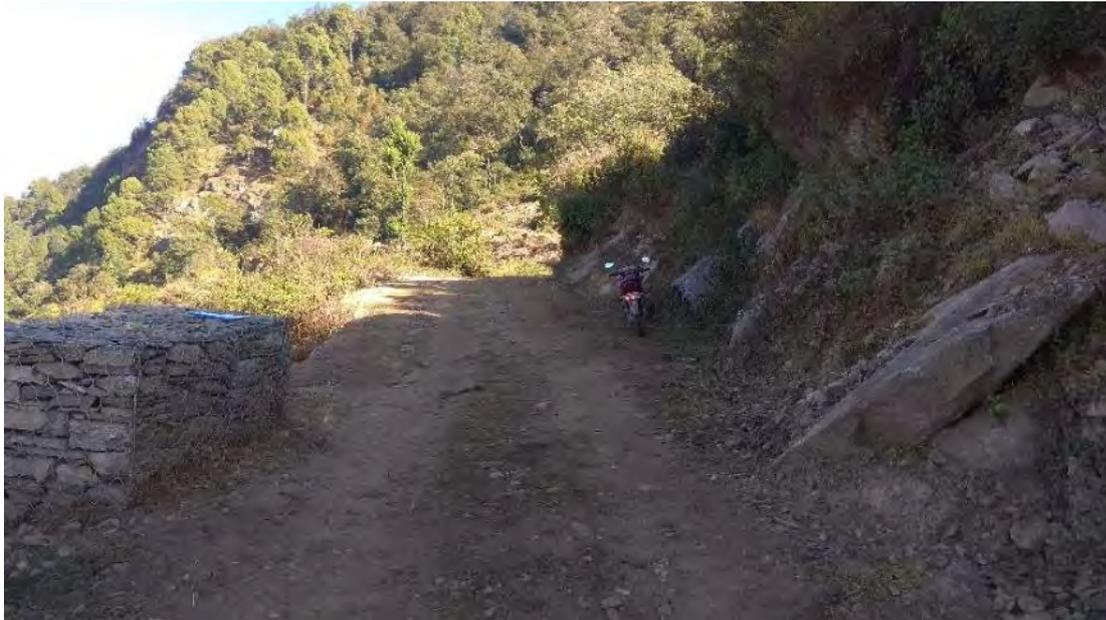
- The width of the road is consistently above 4.5m (as per DoLIDAR rural roads specifications), and exceeds this in most of the sections, with few exceptions (for example at section 13+000-13+005 where a width of 3.1m was observed. This width is fine given the probable instability than can occur by moving boulder strata).

Photo 2: Width of 3.1m at chainage 13+000 where rock was not cut because movement may cause slope destabilisation

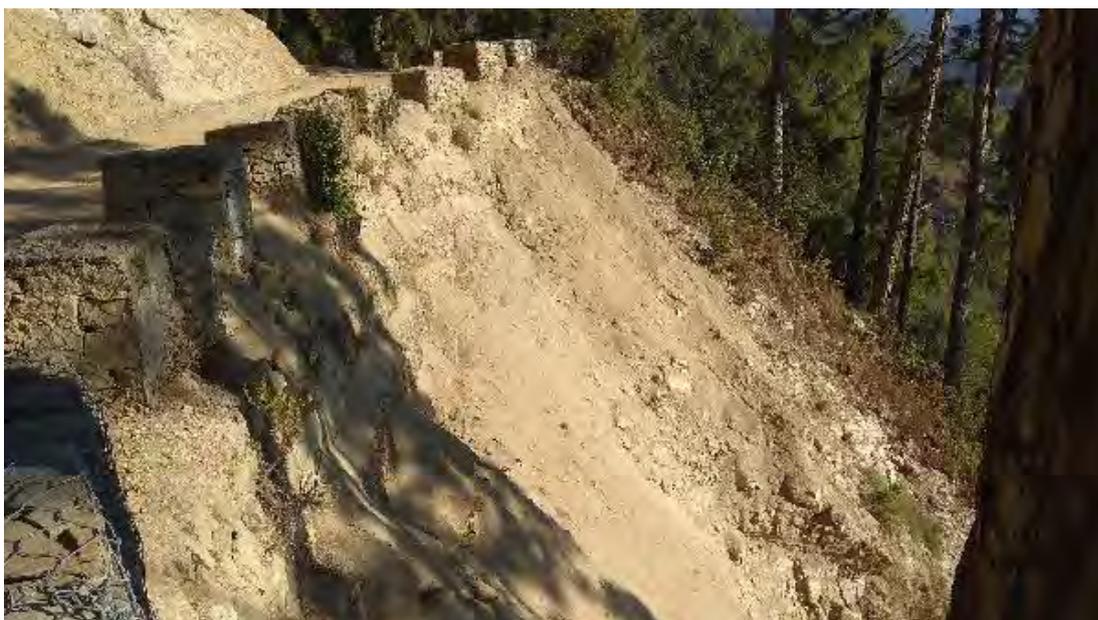
Photo 3: Chainage 14+250 to 14+270: Composite wall and crash barriers with minimal bioengineering works on slope

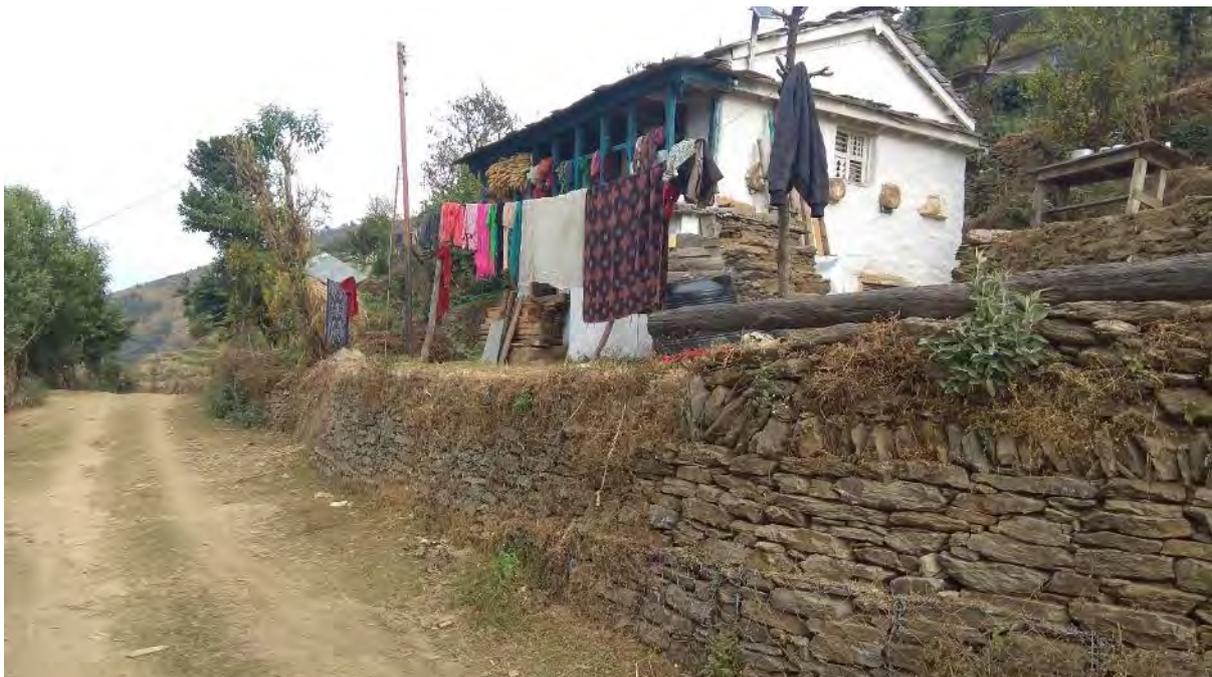
- Gabion retaining walls are constructed to protect houses on the hill side in chainages 7+980, 8+230 and 16+580.

Photo 4: Chainage: 16+580. Gabion retaining wall for protection of settlements on the hillside provided.

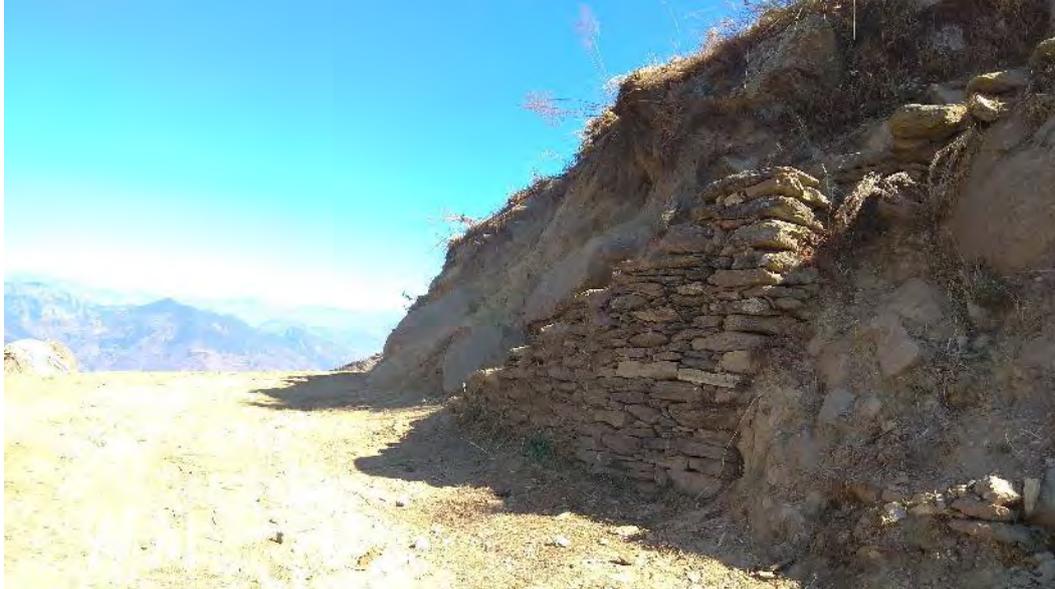
- Foot trails were constructed for easy movement for pedestrians at chainages 8+940, 9+170, 9+390, 10+000, 10+720, 10+900, 11+510, 11+760, 12+900, 13+700, 15+400 and 15+960.

Photo 5: Chainage: 9+390. Foot trails constructed.

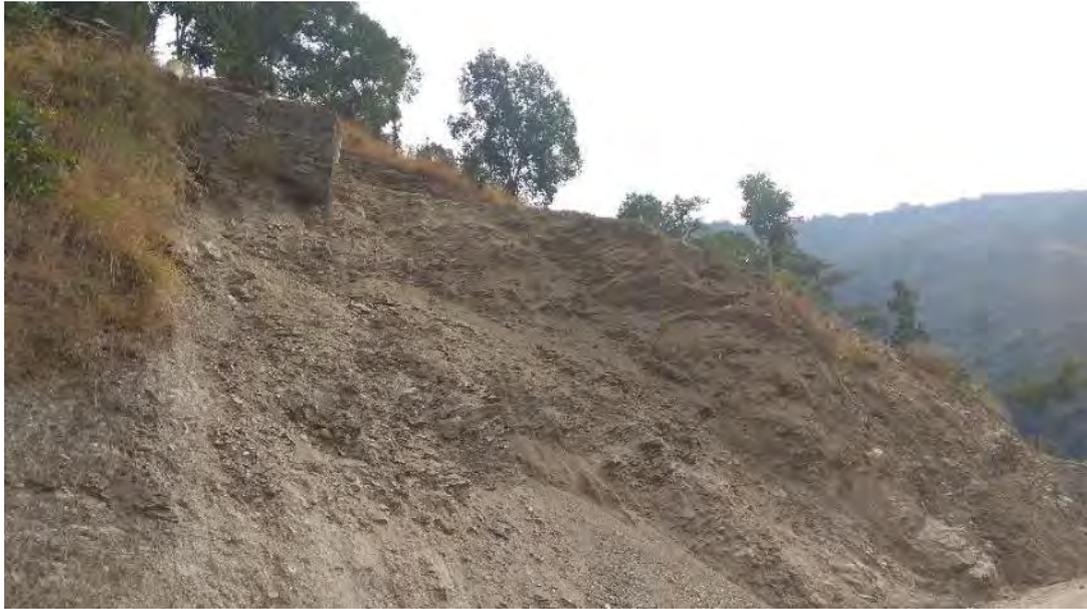
Photo 6: Chainage 3+850. Gabion wall on the verge of toppling/collapse

3	The retaining structure at chainage 3+850 (about to topple), 5+650, 7+300, 11+520 and 15+800 (bulging) should be replaced or maintained as early as possible as they can cause problems of landslides or road accidents.	We have removed the remaining overhanging wall and done back cutting where the road width was narrow (3+850). At Ch 5+650 and 7+300 provisions are working well with no further rectification needed. The wall at Ch 11+520 has been inspected and no bulge is evident. We have completed rectification of the wall at Ch 15+800.
4	Some locations require causeways, such as at chainage 7+900 (to manage water from kholsi) and chainage 9+120 (to manage tap water).	We have since constructed causeways at Ch 7+900 and placed the HDPE pipe to cross the tap water at Ch 9+120.
5	Eroded debris to causeway should be cleared in a timely manner for proper functioning of causeway. For example, Causeway at 7+630 and 3+200 requires clearance of debris materials.	All landslide and debris have now been cleared.

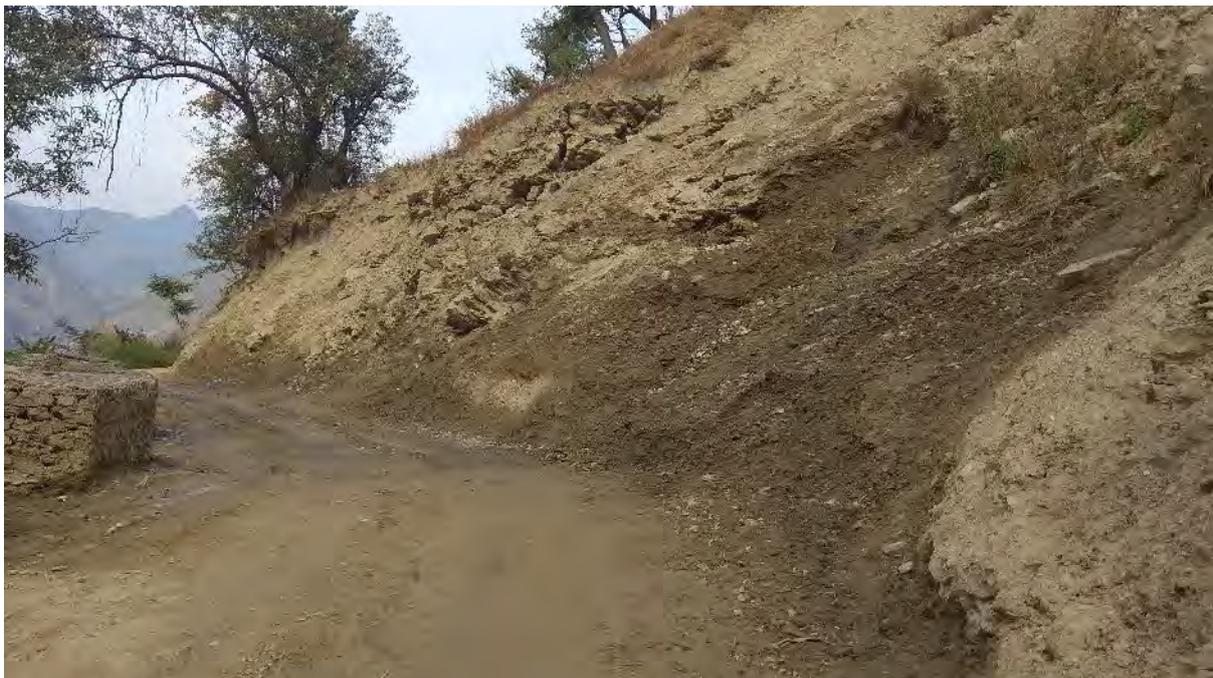
Photo 7: Chainage 4+410. Seepage from landslide which requires mitigating measures.

6	Problems which are in critical stages including seepage from rocks (e.g. at chainage 3+300) and seepage from landslide scarp (e.g. at 4+410) should be properly accounted	We have since installed a HDPE pipe to cross the seepage water.
7	Side drains should be constructed and integrated to cross drainage structures or camber should be provided properly to manage rain water and water from kholsi in most of sections.	We have provided side drains where required and feasible (RAP3 standard approach is for outward sloping roadway except in special cases). 'Finishings' team has since maintained the outward slope throughout the alignment.
8	Bioengineering works should be conserved, maintained and inspected in a	Bio-engineering works have generally faired very well on this alignment and are under the care of RMGs. There may be further opportunity for further minor Bio-engineering

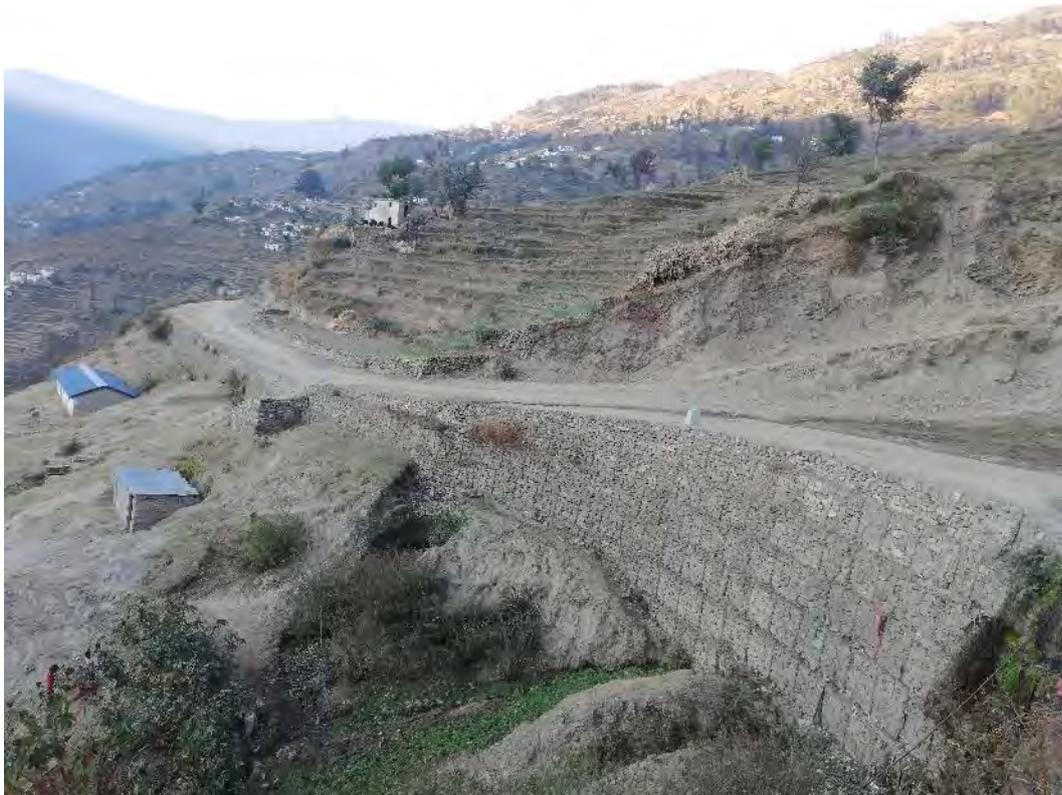
Photo 8: Chainage 14+000. Good example of good overall condition, road build, geometry and construction.

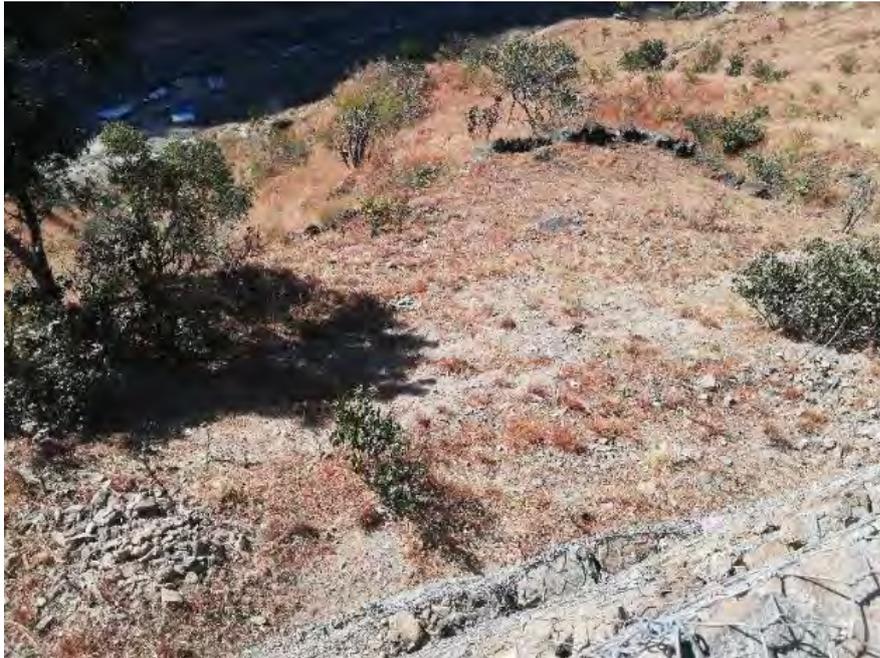
The present pavement surface is good and levelled in most of the sections. Bioengineering works have been completed in a few sections (e.g. 1+400 and 2+700) which are functioning well.

Photo 9: Chainage 2+700: Bioengineering works to a good standard.

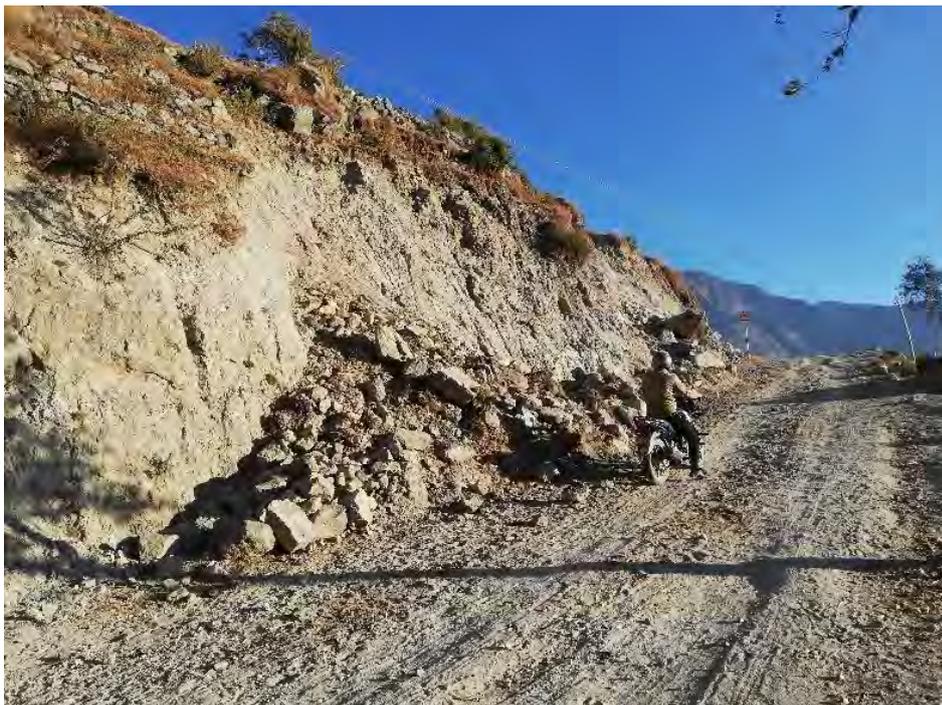
Photo 10: Chainage 12+460. Observed landslide.

- There is existing and potential minor landslide in the hairpin bends, curve and other locations due to fragile topography and cutting of natural slope. Hence, slope stabilization work should be done to improve slope stability (e.g. 0+500, 0+700, 1+100, 3+600, 3+700, 4+370, 5+300, 6+900, 7+800, 10+010, 11+720, 12+460, 13+060, and 16+320).

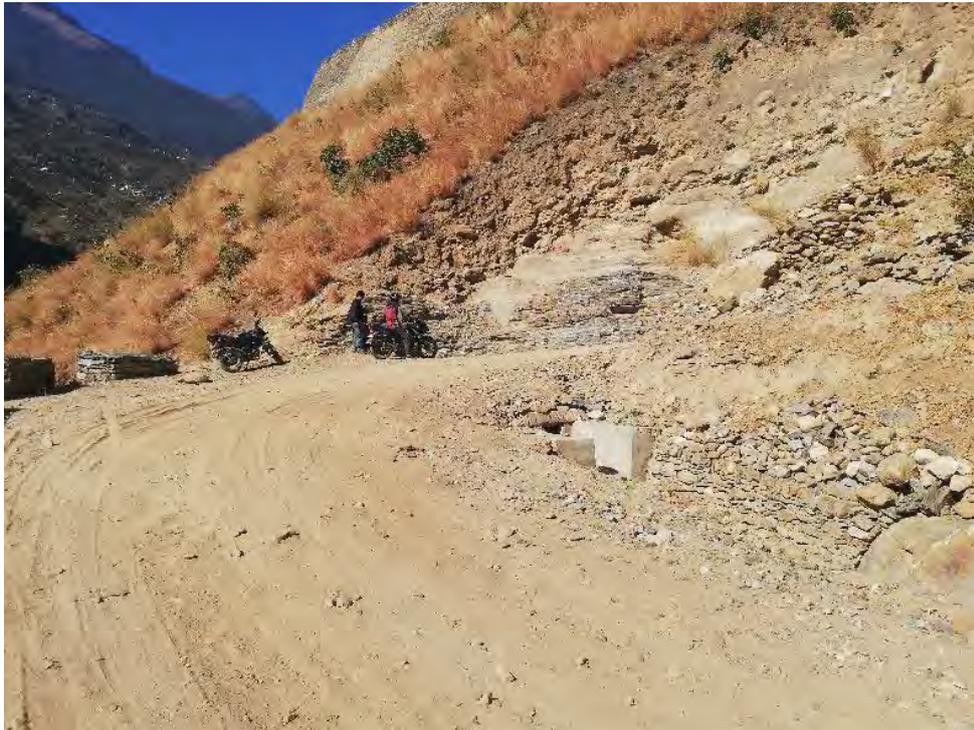
Photo 11: Chainage 1+100. Hairpin bend could require further slope stabilisation

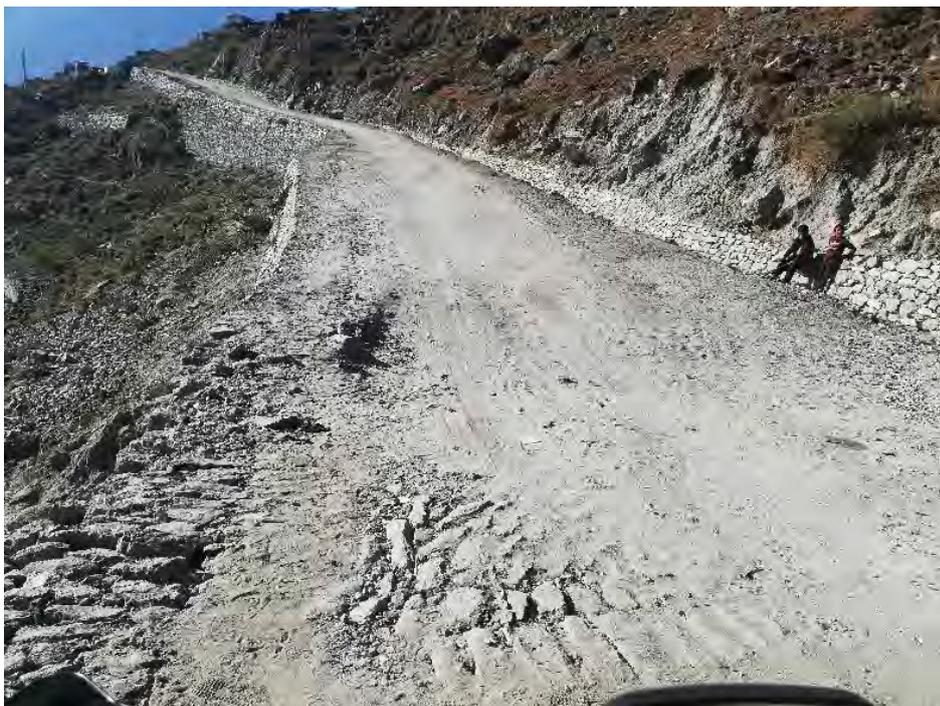
Photo 12: Chainage: 11+900. Cross-drainage water management structure has eroded and requires maintenance

- Water management structures need to be improved (e.g. 0+100, 2+010, 2+260, 2+310, 4+298, 7+400, 9+817, 10+500, 11+900, 12+400, 13+640, 14+080, 15+680, 15+900, 16+280, 16+815, 17+150).

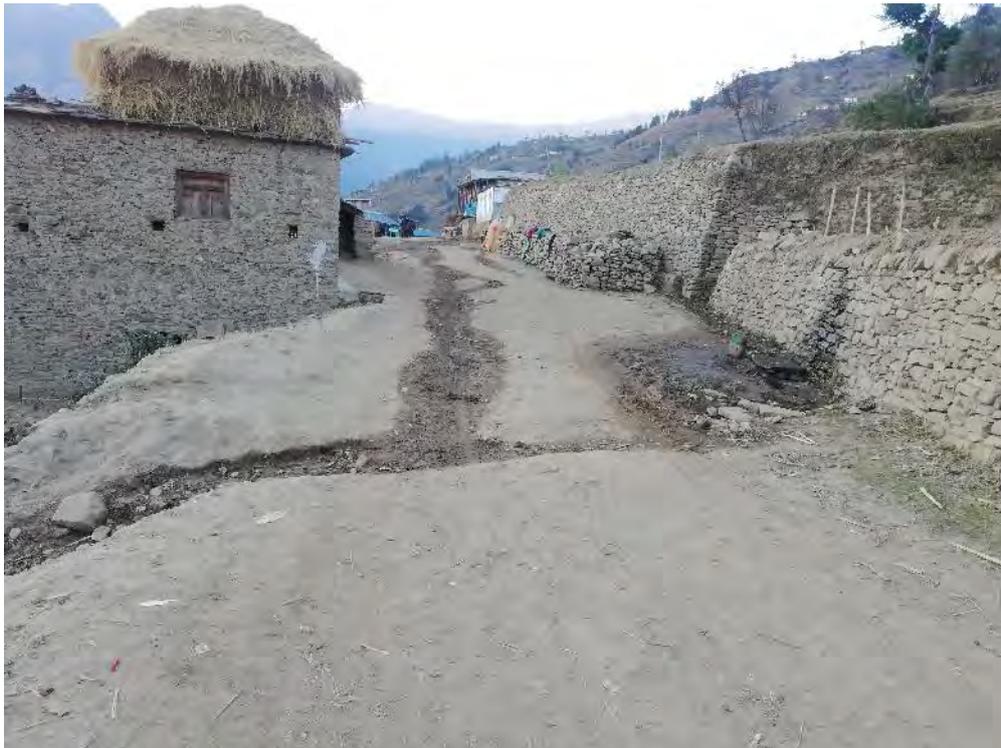
Photo 13: Chainage 15+900. Minimal side-drain and stone piling. Pipe required for water drainage.

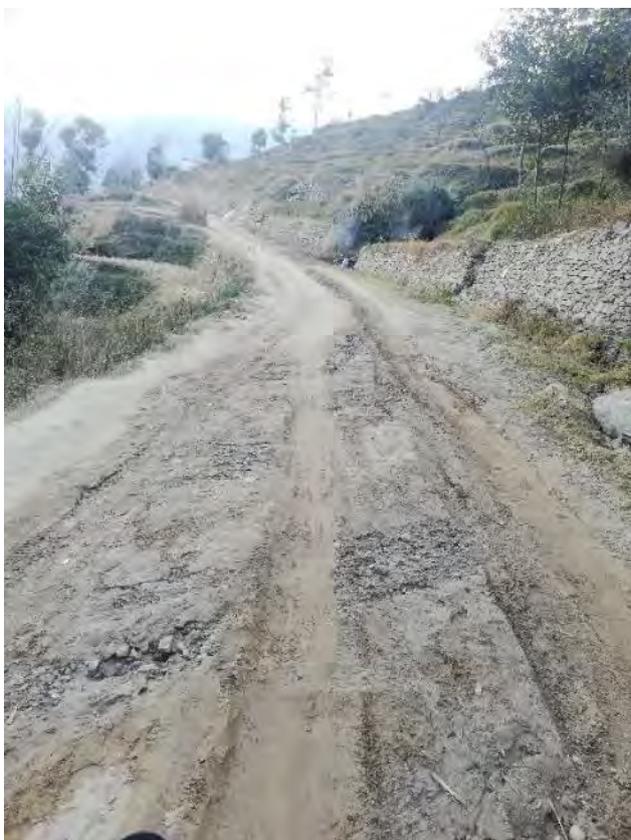
Photo 14: Chainage 15+480. Routine and recurrent maintenance activities to be performed regularly.

- Routine and recurrent maintenance activities of road should be performed regularly (e.g. 15+480).

3	Routine and recurrent maintenance activities of road should be performed regularly (e.g. 15+480).	As mentioned above, RMGs have been handed over to the Municipality to take care of these matters.
4	The road safety structures such as delineator post or block is not adequate. More safety structures need to be provided at the required site. (e.g. 9+000, 12+000).	Prior to substantial completion RAP3 conducted a Road Safety Audit of the full alignment by a highly experienced road engineer specifically trained in road safety issues. All the Audit recommendations have been completed including erection of traffic warning signs and gabion barriers at sharp bends. It is not possible to eliminate all traffic risks and generally barriers have not been provided where the side-drops aren't severe or the bend is not acute.
5	Traffic sign and milestone blocks need to be maintained (e.g.0+000, 4+000, 8+200, 9+817).	Traffic warning signs have suffered vandalism from bored youths / school children (they have managed to peel off some of the black legends). We have agreed a rectification whereby the legends are reapplied by stencil and black enamel paint. At the same time the milestone blocks will have legends applied (programmed in mid-Jan 2019).

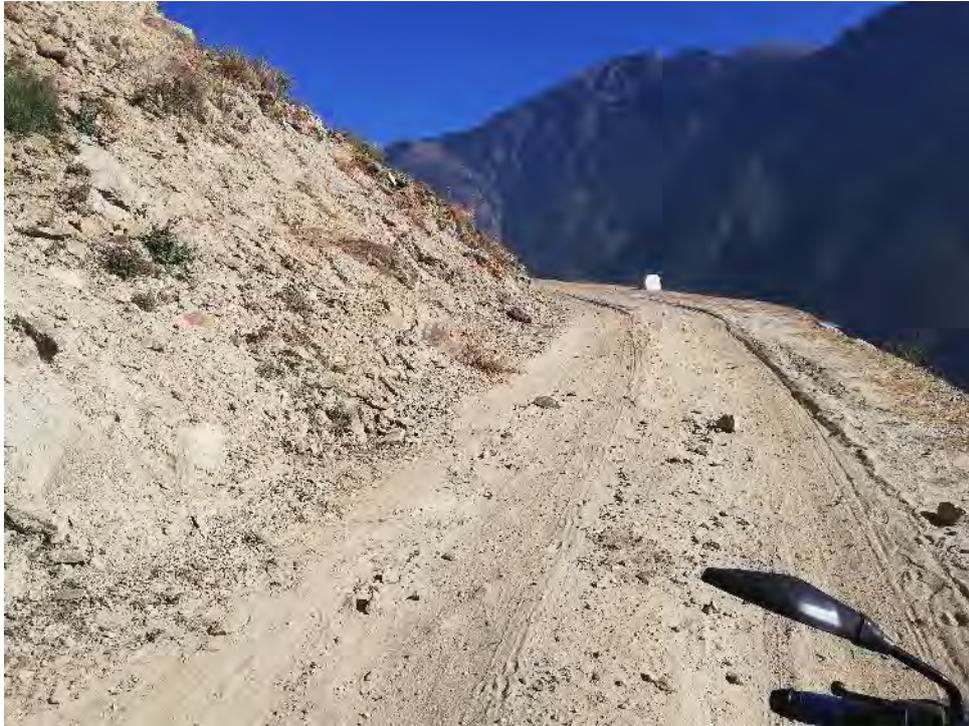
Photo 15: Chainage 12+000. Safety structures at steep curve should be considered.

- The road safety structures such as delineator post or block is not adequate. More safety structures need to be provided at the required site. (e.g. 9+000, 12+000).

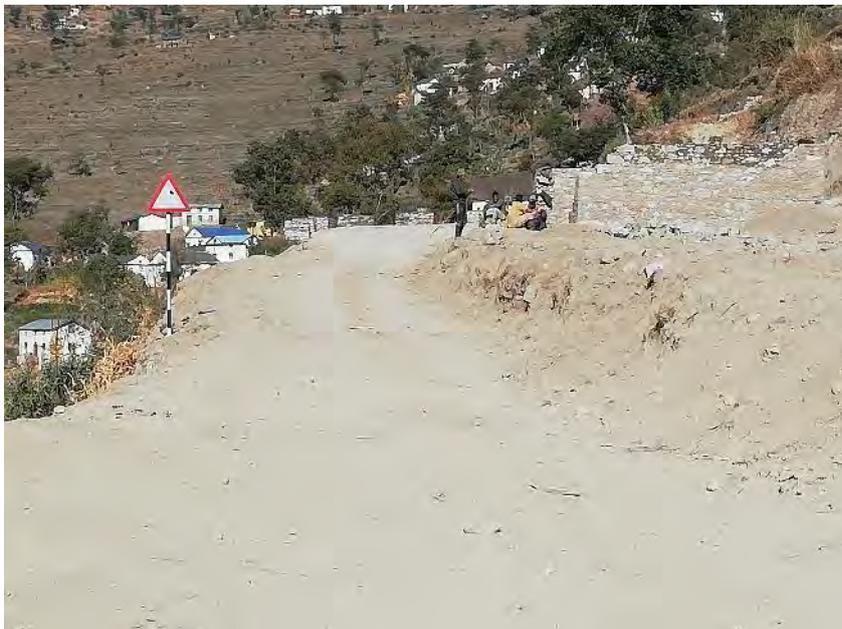
Photo 16: Chainage 8+200. Traffic sign not properly visible and requires fixing.

- Traffic sign and milestone blocks need to be maintained (e.g. 0+000, 4+000, 8+200, 9+817).

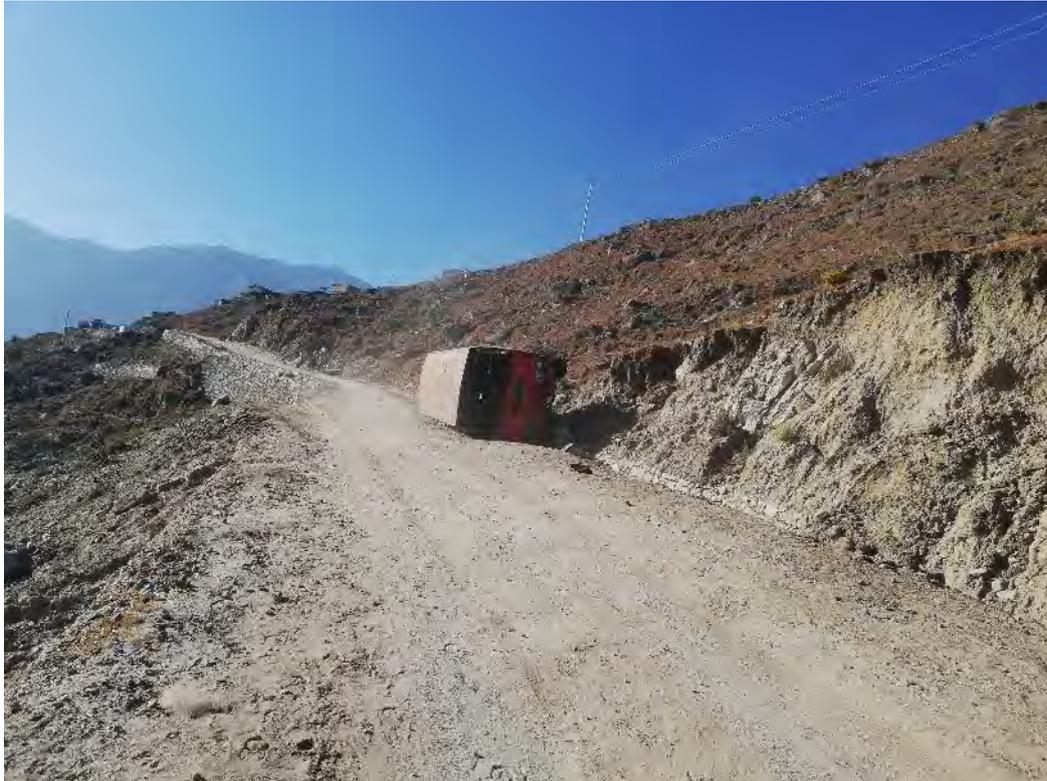
The photo below along the newly constructed RAP road in Kalikot shows an observed road traffic accident. This serves to spotlight issues that are known to occur in rural Nepal and is not indicative of the road quality or the work completed by RAP.

Photo 17: Chainage 11+000. Observed road traffic accident.

The Government of Nepal should prioritise road safety awareness and enforce these on all roads, particularly these newly constructed roads. Road safety and its promotion and enforcement should continue to be emphasised and prioritised at all levels of government.

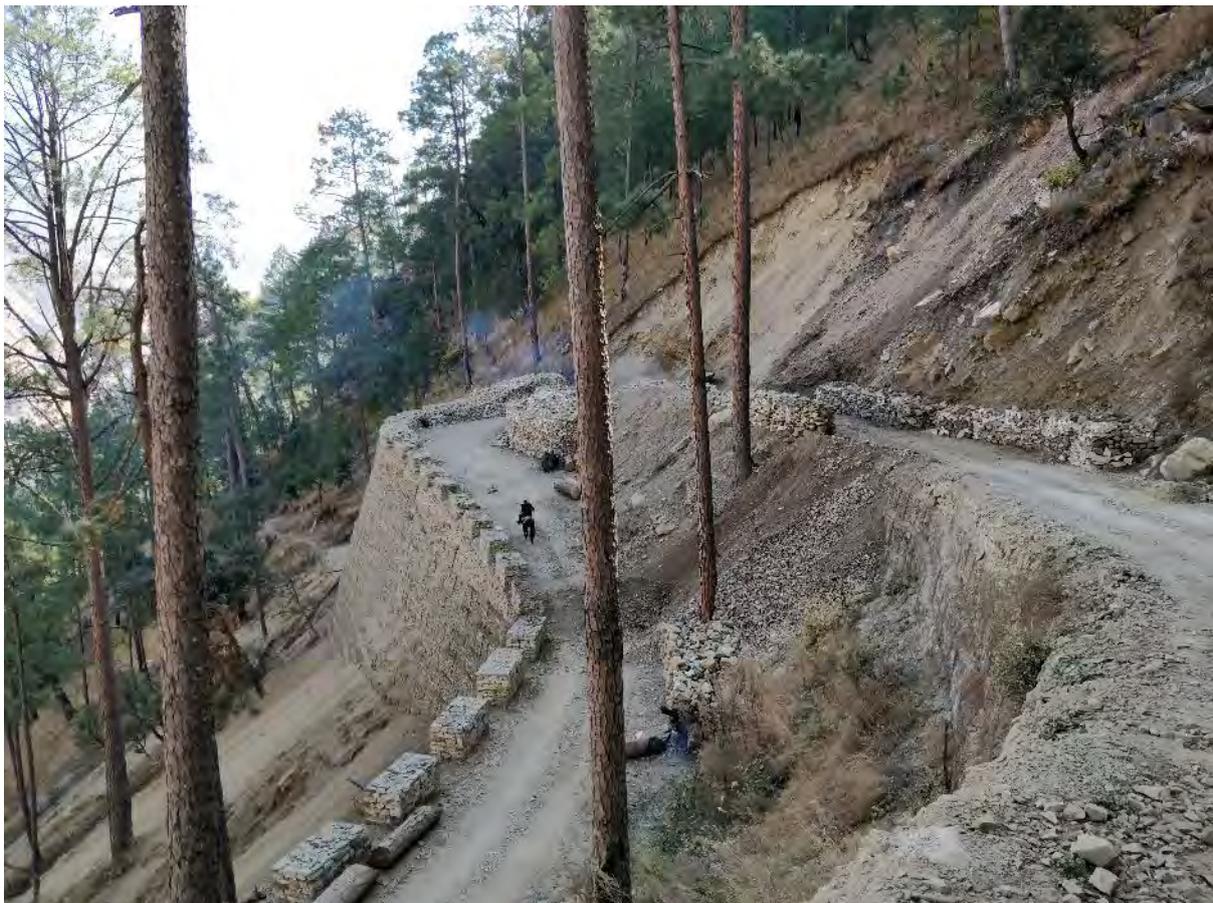
Photo 18: Chainage: 7+250. Good construction with adequate structures in place on steep terrain

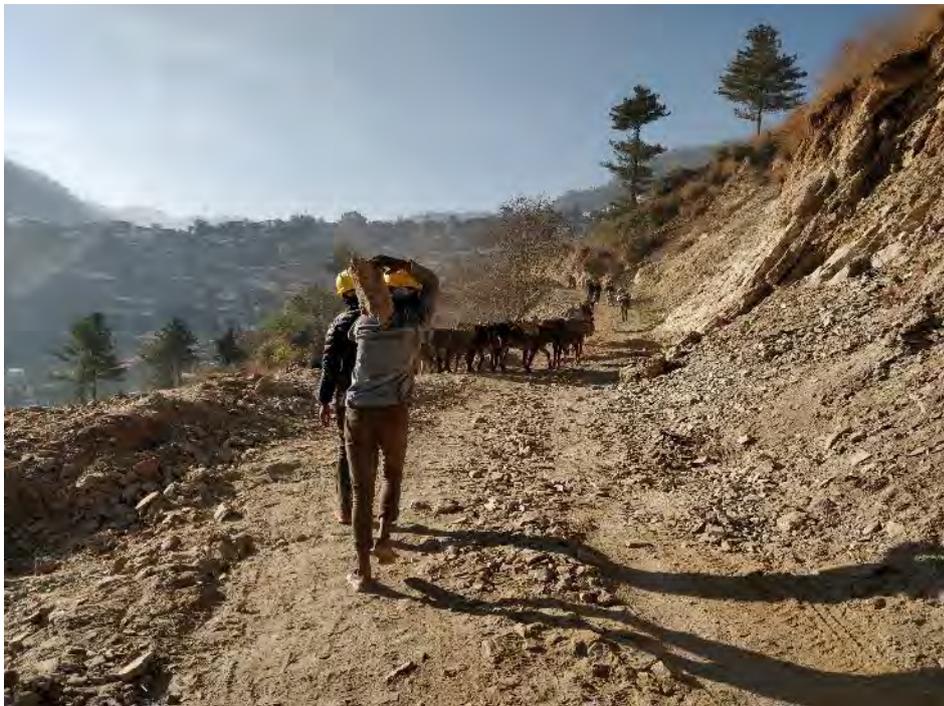
Photo 19: Chainage 0+900. Quarry site with potential landslide risks.

Protection is required of sites which could cause landslide and damage the road section. For example, Quarry site (0+900), some landslide side zones (eg.7+150), loose rocks (9+530) and debris fall area (10+250) and trees in many sections may create obstruction to vehicular movement and to the road structure.

1	Protection is required of sites which could cause landslide and damage the road section. For example, Quarry site (0+900), some landslide side zones (eg.7+150), loose rocks (9+530) and debris fall area (10+250) and trees in many sections may create obstruction to vehicular movement and to the road structure.	Further protection work has been done by construction of Gabion Breast walls in many sections. Budget limitations have limited the scope of gabion breast wall construction in non-essential areas. Slope trimming and removal of overhanging/outcropped boulders etc. has now been completed in critical sections. Fallen debris have been removed from the road.
2	No side drain was seen along the road. Although not specified in design, drain should be provided in most of the sections. Although there were causeway structures, there were no appropriate road pavement completed in causeway areas for example (1+600, 9+980, and 13+150)	RAP3's construction approach is to construct outward sloping pavements in preference to side drains except in special cases (e.g. steep gradients / waterlogging, etc.). This final trimming of pavement slope has now been completed. Most of GDDR section is rocky resulting in a granular road surface. Generally this does not require DS drain as suggested. Dry stone causeways have been constructed in perennial Khola/Kholsi. This was verified in safety and climate resilience audit conducted by TMO.

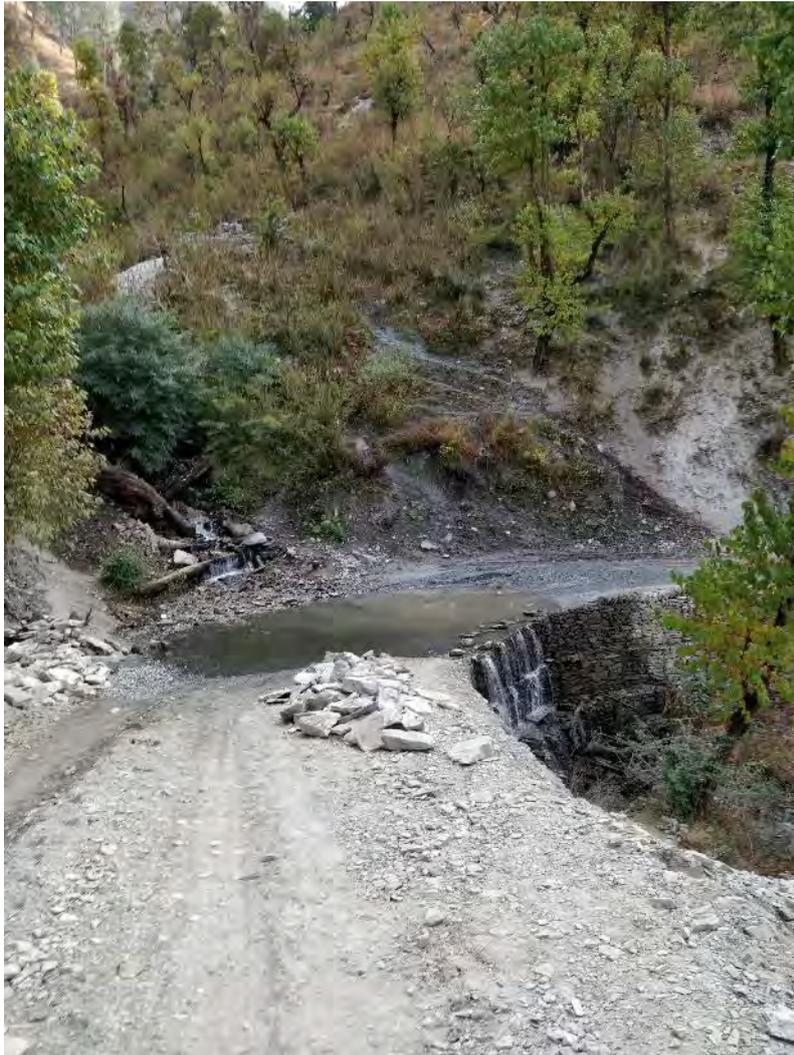
Photo 20. Chainage: 13+150. Lack of adequate cross-drainage creating waterlogging (Observation in December – relatively dry compared to monsoon season).

No side drain was seen along the road. Although not specified in design, drain should be provided in most of the sections. Although there were causeway structures, there were no appropriate road pavement completed in causeway areas for example (1+600, 9+980, and 13+150)

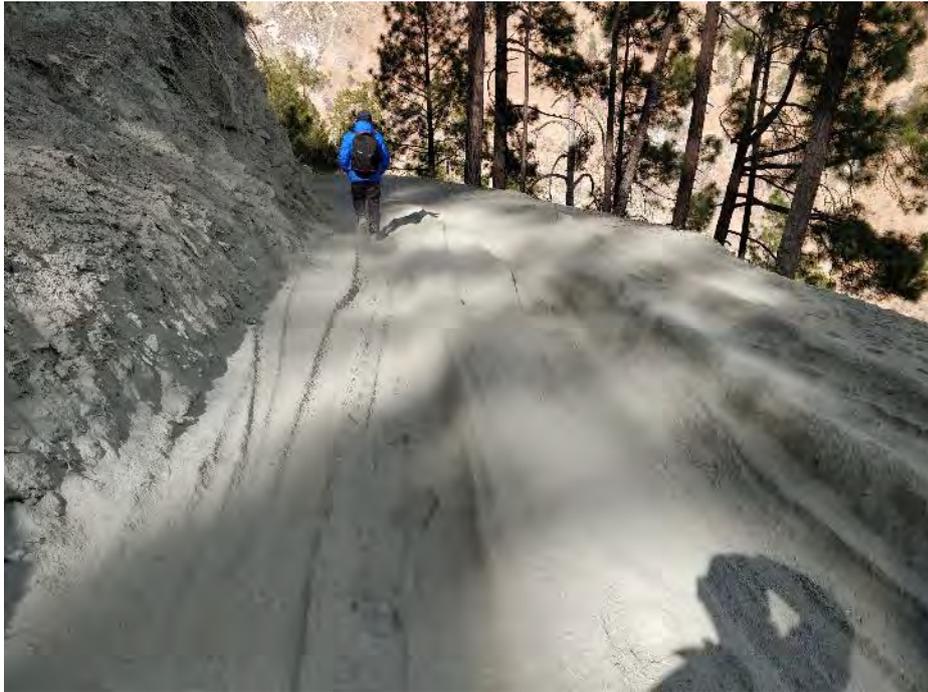
Photo 21. Chainage 10+650. Dusty sections of road.

Pavement surface in certain section were too dusty (eg.1+250, 10+650) and rocky (10+200, 18+200). An appropriate solution should be applied in such areas.

3	Pavement surface in certain section were too dusty (eg.1+250, 10+650) and rocky (10+200, 18+200). An appropriate solution should be applied in such areas.	Dusty pavement sections have now been filled by granular material founded near site. In rocky sections oversized material has been removed.
4	Bioengineering works should be conserved and maintained. Traffic signs and mile stones should be installed. Widening of road section and provision of lay-bys should be done for movement of big and heavy vehicles. Routine and recurrent maintenance works should be started as the traffic operation has been already started.	Bio-engineering work was done during last three years in appropriate locations. But fertilisation rate is very low in Mugu, so could not be achieved fully as planned. Inventory of Traffic signs has been sent for procurement and is ongoing. Lay-bys are not geometrically shaped, but vehicles can pass adequately in road sections of increased width. RMGs have been formed for routine/recurrent maintenance. Budget is allocated from Province for RMG work and is in process to mobilise.
